4 DEFENSIVE ARCHITECTURE OF THE MEDITERRANEAN XV to XVIII Centuries

Survey and Deterioration Analysis for the Restoration of Fortified Architecture: Case Study of the Malta Walls.

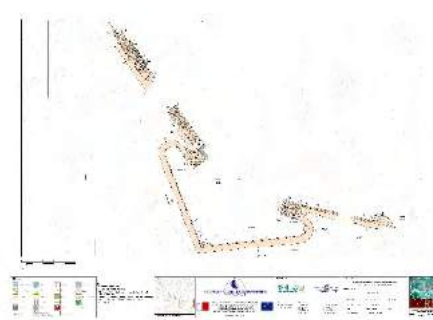
Like all the ramparts of the town, the wall sections analysed in Valletta (fig. 1) were built by shaping the natural bench of soft local limestone. The summit and other strategic areas, both constructively and defensively, were realized with rows of square blocks made of the same material. The walls were built following the specific morphology and altitude profile of each site, with heights varying between 10 and 30 m. The height of the stone blocks varies between 30 and 45 cm and the width between 70 and 100 cm. The different sides of the walls have different heights, constitution and assets.

Fig.1- General plan of Valletta survey.

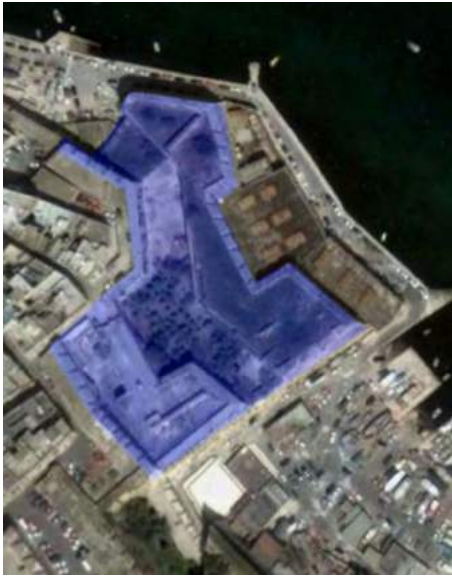
The sections of walls analysed in the 'Post of Castille' in Birgu (fig. 2) were built, as in the case of Valletta, mainly by laying horizontal rows of square blocks of the same stone. In some places the wall is directly on the limestone bench. The entire outer face of the section analysed is typically built with a scarp wall profile culminating in a rectilinear section interposed with battlements. These are in most cases preceded by a moulded cornice which consists of a 'cyma-strip-taurus' sequence.

Fig. 2- Birgu, Malta. Aerial photograph of 'Post de Castille' (Laura Baratin 2011).

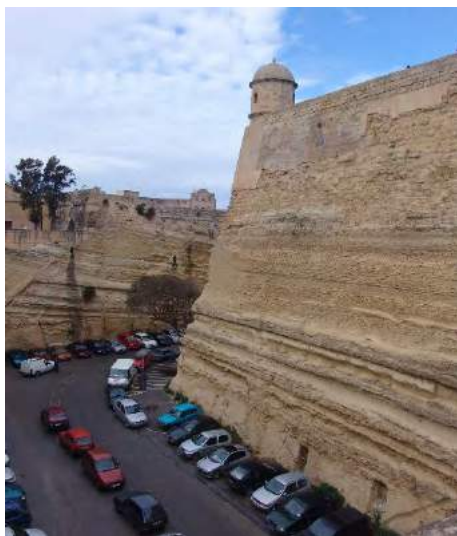
continuous deeply weathered bands in the limestone bank (fig. 7). Masonry deterioration appears less aggressive because of two reasons principally: the better quality of the ashlar stone, carved from the quarry, and the common practice of replacing masonry developed in the last century. In addition, another frequent pattern regards the numerous cracks of the stone bench, related to geological settling. Alveolar weathering, scaling and flaking may be interpreted as gradual degradation that culminates in powdering and deep weathering of the stone [Cassar 2002].

Fig. 7- Valletta, Malta. Rock bench and masonry degradation (Marta Acierno 2011).

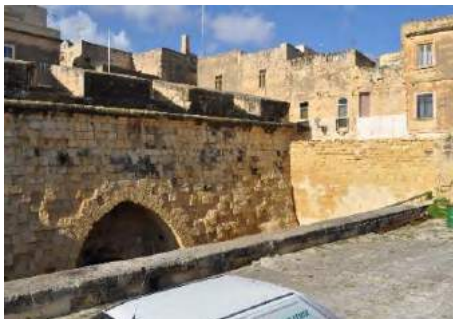
Another esogenous factor is thermal oscillation that produces a continuous alternation of expansion and contraction, and occurs above all in sunny areas which are more exposed to temperature fluctuations (fig. 8).

Fig. 8- Birgu, Malta. Scaling and back weathering on southern fronts (M.Acierno 2011).

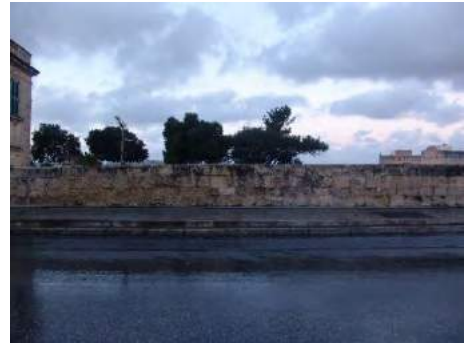
Alveolar weathering is mainly due to the crystallization of salts. In those places which are more exposed to sunshine or air movements on the stone surface, the rate of water evaporation in the masonry is greater, and the phenomenon is amplified. The most affected areas are, therefore, the southern fronts and those with better ventilation in the north-west. Alveolar weathering is also particularly evident on the interior of the walls where the phenomenon is emphasized by dampness caused by rainwater pooling at the foot of the structure (fig.9).

Fig. 9- Valletta, Malta. Alveolar weathering on the parapets facing the town (M. Acierno 2011).
